Flood Control Project Maintenance
2009 Structure Summary Report
Overall Unit and Item Ratings

DWR Sutter Maintenance Yard

Flood Control Project Maintenance**Unit Cover Sheet****2009 Structure Inspection Results****DWR Sutter Maintenance Yard**

Levee Inspection Report By Mile - Structure 2009

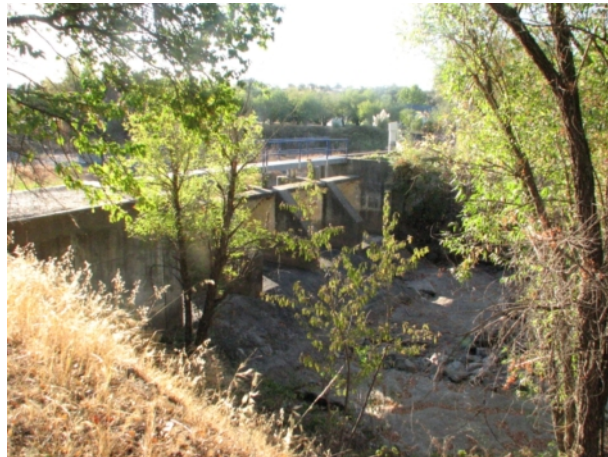
Levee Mile Report Line	1
Start Levee Mile	0.00
End Levee Mile	0.00
Location	
Category	Structures
Item	Vegetation & Obstructions
View of the vegetation downstream from the structure.	
rduffey_20080917_32.jpg

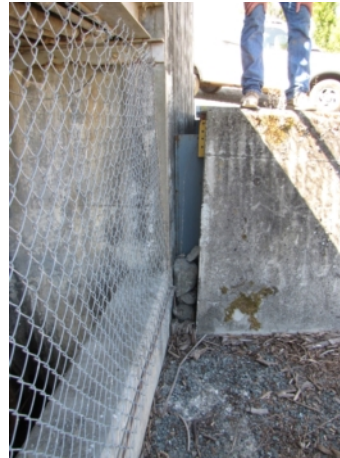
Levee Mile Report Line	3
Start Levee Mile	0.00
End Levee Mile	0.00
Location	
Category	Pump Stations
Item	Plant Building
View of the gap between the main station foundation and the side chamber caused by differential settlement.	
dpesaven_20090819_53.jpg

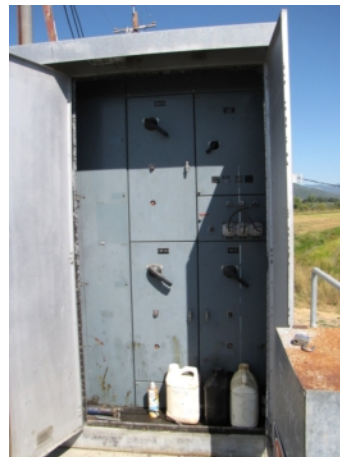
Levee Mile Report Line	10
Start Levee Mile	0.00
End Levee Mile	0.00
Location	
Category	Pump Stations
Item	Pump Control Systems
View of the pump controls. The pumps can be manually operated or controlled by the water level.	
dpesaven_20090819_59.jpg

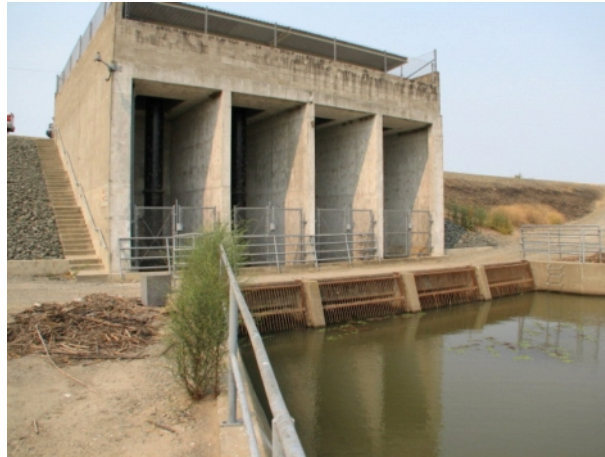
Levee Mile Report Line	12
Start Levee Mile	0.00
End Levee Mile	0.00
Location	
Category	Pump Stations
Item	Trash Racks
Photo of trash rack, wet wells and safety fencing temporarily removed for trash removal.	
jpaasch_20090812_43.jpg

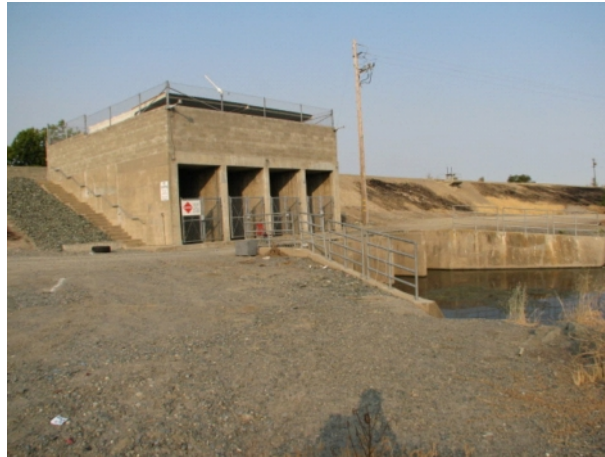
jpaasch_20090812_30.jpg

Photo of intake side of the pumping plant showing missing guard rails at the trash racks.
